TURBO CARE

Expensive turbo failures can be avoided. Chris Kambouris of TurboDirect points out some of the primary causes of turbo mishaps, and how to keep them in check...

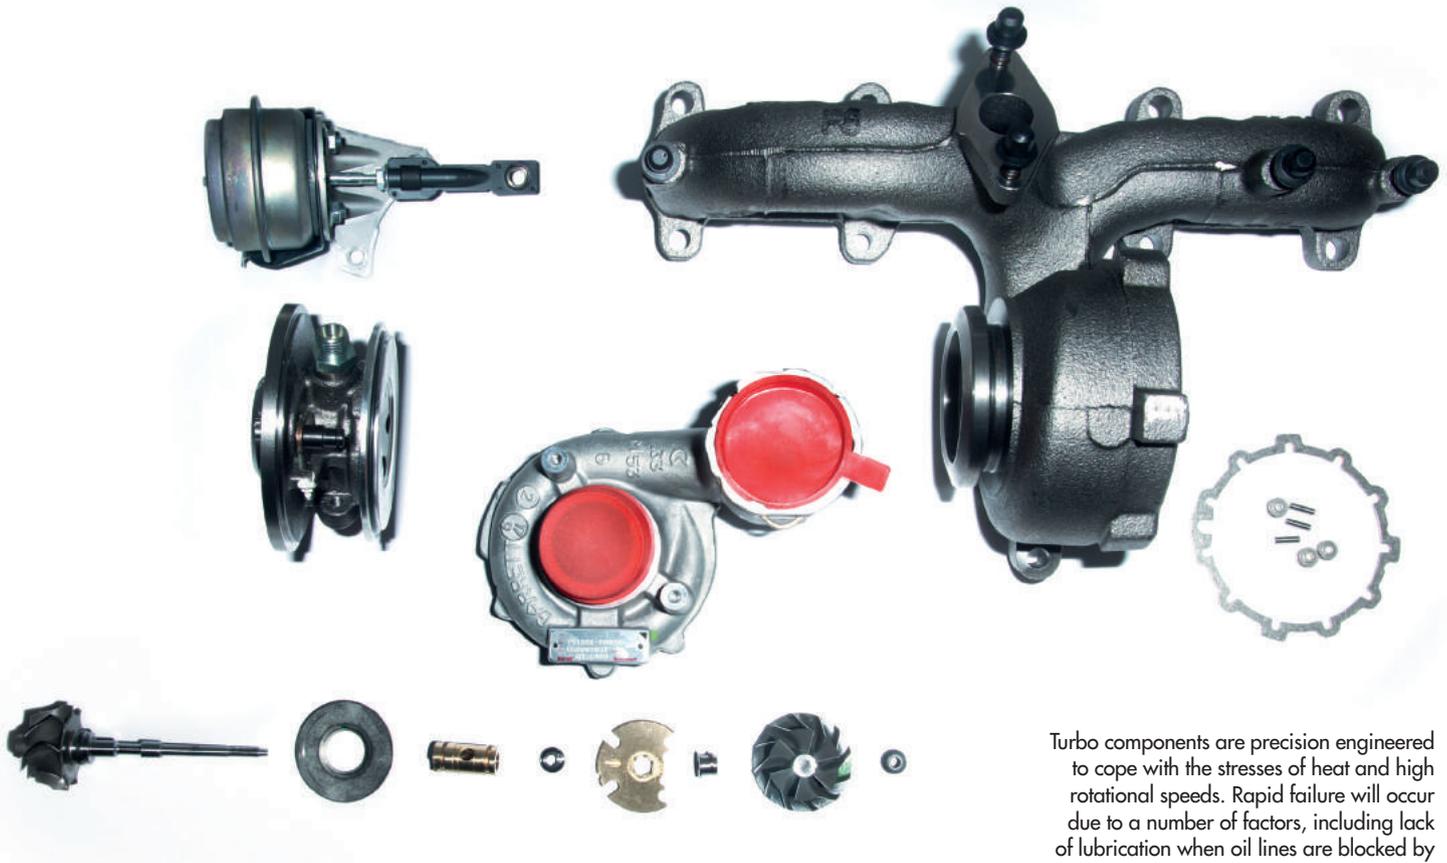
Turbo components are precision engineered to cope with the stresses of heat and high rotational speeds. Rapid failure will occur due to a number of factors, including lack of lubrication when oil lines are blocked by dirty oil (or oil breakdown), or when pitting occurs on the blades, causing imbalance.

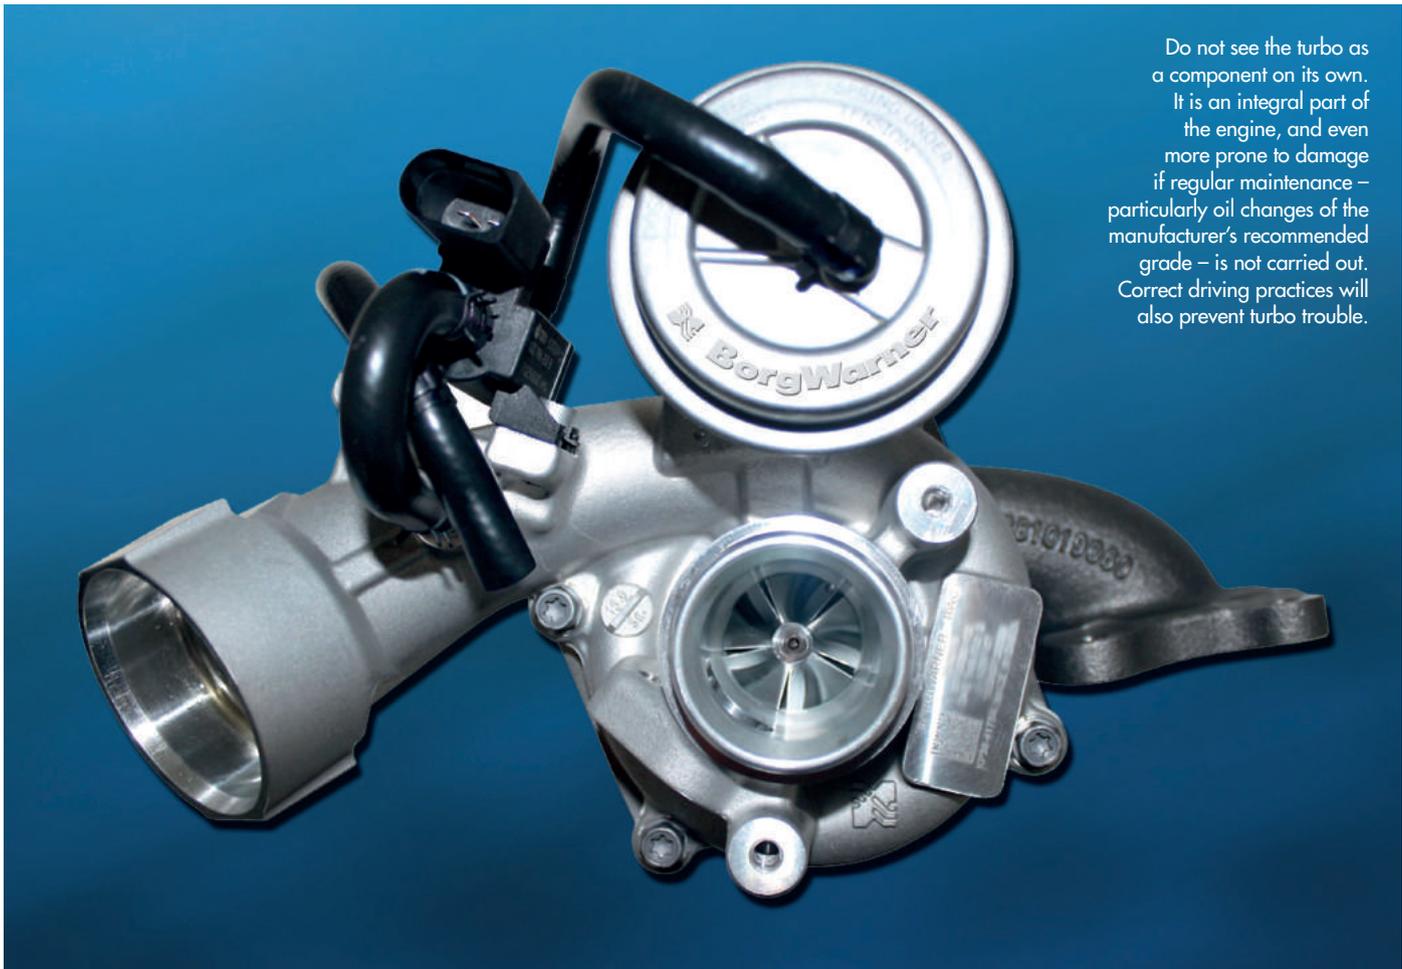
Do not see the turbo as a component on its own. It is an integral part of the engine, and even more prone to damage if regular maintenance – particularly oil changes of the manufacturer’s recommended grade – is not carried out. Correct driving practices will also prevent turbo trouble.
